Detailed RAAC Inspection Report

Project Name: NHS RAAC Inspections
Project Number: UK70098755
Inspection Date: 21 & 28 August 24
Engineers: #020, #016, #013, #002,
Checker: #002
Approver: #002
Issue date: 28/10/2024

NHS Board: Ayrshire & Arran
Site Code: B114H
Site Name: University Hospital Crosshouse
Block Number: 03
Block Name: Lister Centre
Discovery Report: WSP-RP03-A111H-3-University Hospital Crosshouse_Lister Centre
Structural Engineers: #020, #016, #013, #002
NHS Estates: Fraser McNeil

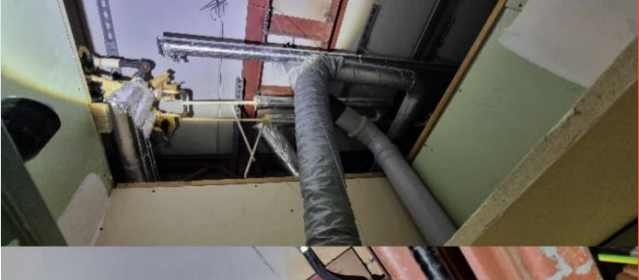
L21	GRN.2.Mid.4.R.5.D120 pipe, approx 150 hole.7.8

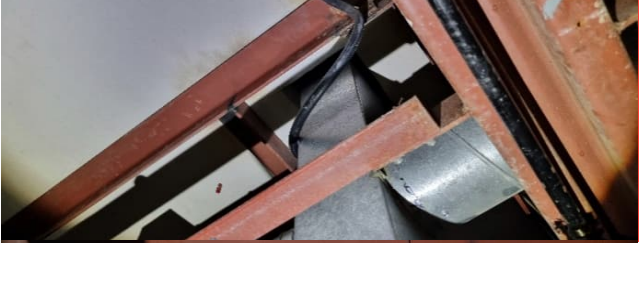
L22	GRN.2.Edg.R.5.D200x300 hole, 150x250duct.7.8

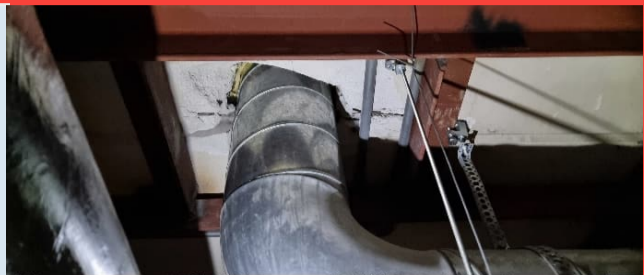
Location	General Condition Code	Repair Detail		Image
		Drawing No.	Detail No.	
L23	GRN.Mid.4.R.5.D200.7.8

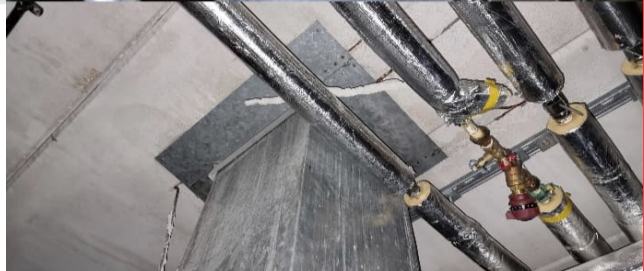
L24	RED.2.Edg.3.4.R.5.D330x330.8	S-00005 S-00002	09 R1

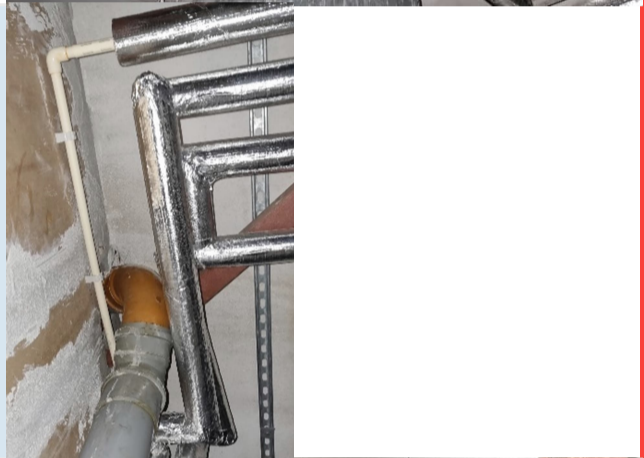
L25	AMB.2.Mid.3.4.R.5.D120dia.8.10	S-00005	09

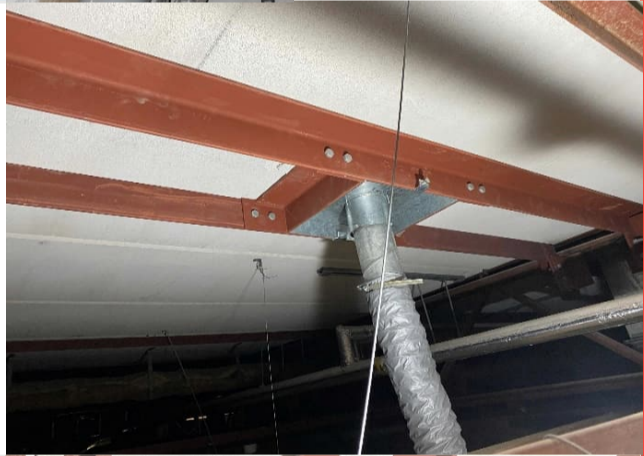
L26	GRN.Mid.4.NR.5.D150dia.7.8

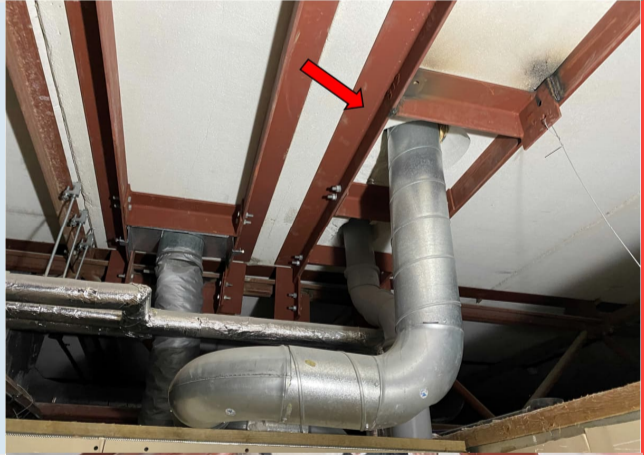
L27	GRN.Mid.4.R.5.D200dia, 400dia hole.7.8

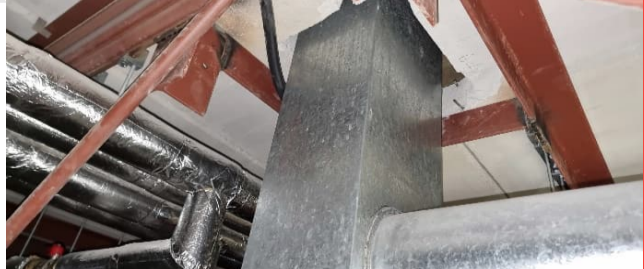
L28	GRN.Edg.4.R.5.D200x300 duct, 350x450 hole.7.8

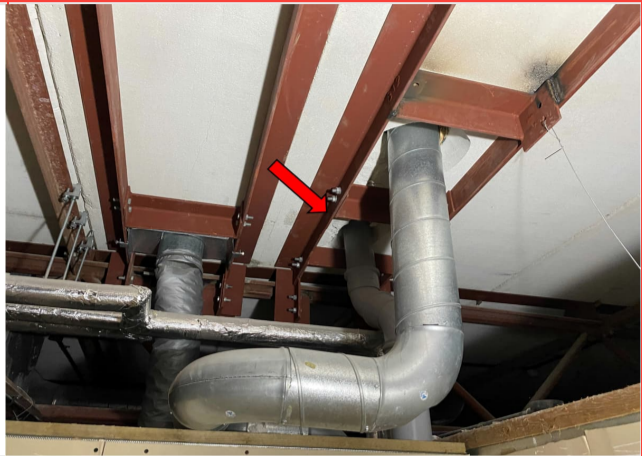
Location	General Condition Code	Repair Detail		Image
		Drawing No.	Detail No.	
L34	GRN.Edg.4.R.5.D150dia pipe, 300dia hole.7.8

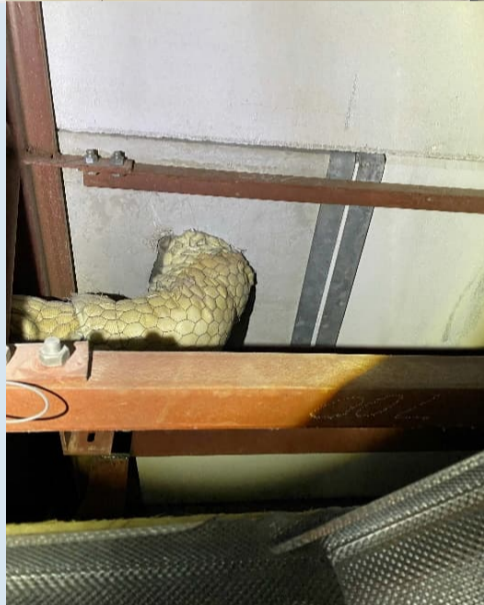
L35	AMB.Edg.4.NR.5.D300d pipe.7.8	S-00005	09

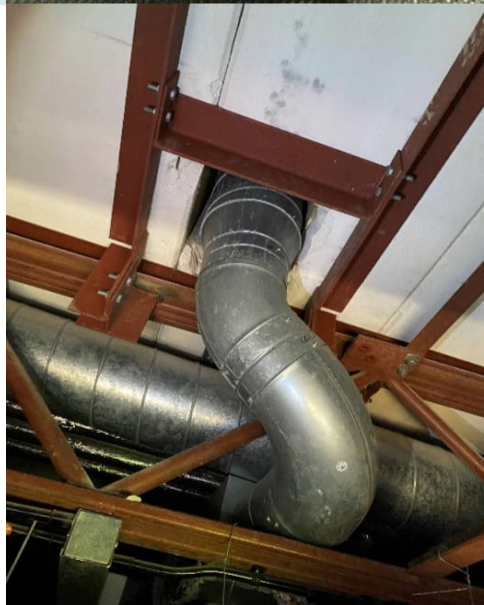
L36	GRN.Edg.4.R.5.D300d pipe,350 square hole.7

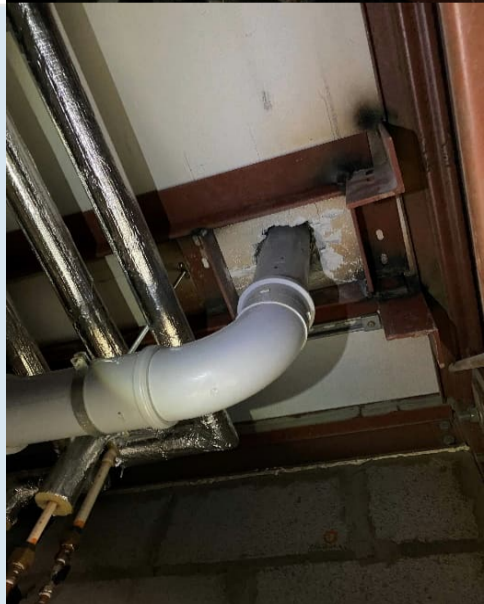
L37	GRN.2.Mid.4.R.5.D150diapipe, 200 hole.7.8

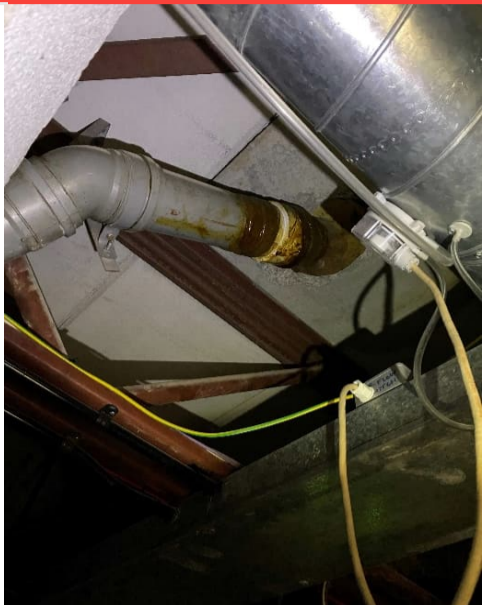
Location	General Condition Code	Repair Detail		Image
		Drawing No.	Detail No.	
L38	AMB.Edg.4.NR.5.D150d pipe, 250 hole.7.8	S-00005	09

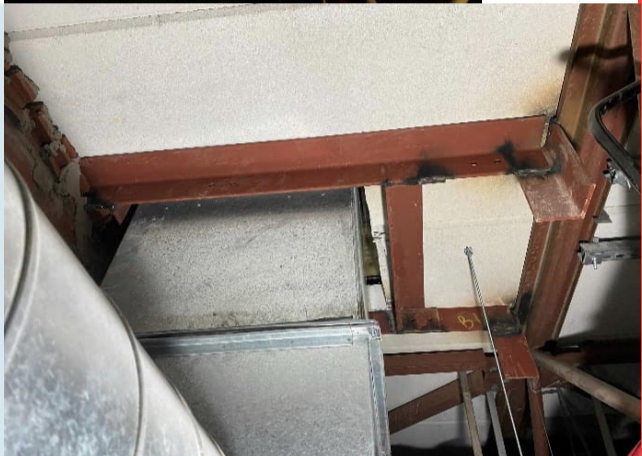
L39	GRN.1.2.Edg.4.R.5.D500square duct, same hole.7.8

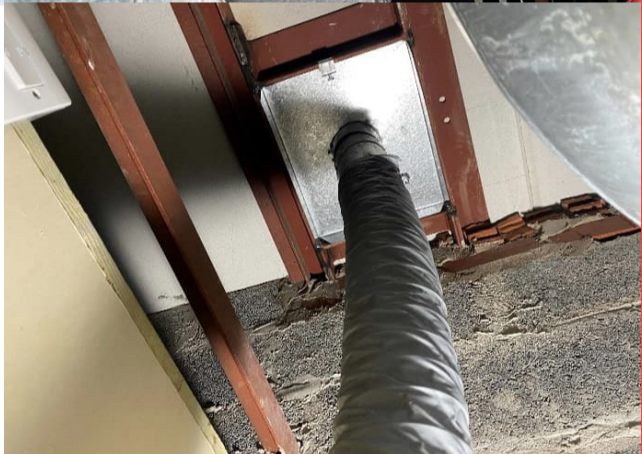
L40	GRN.1.2.Edg.4.NR.5.D120dia pipe, plate covering.7.8

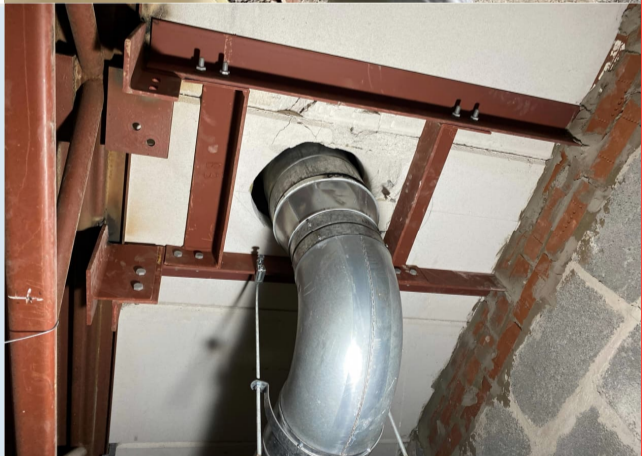
L41	RED.Edg.4.R.5.D300dia pipe, 400dia hole.7.8	S-00002	R1

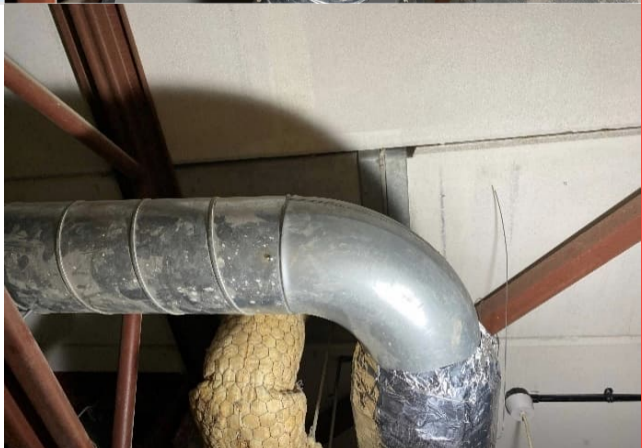
L42	AMB.Edg.4.NR.5.D300dia pipe, .7.8	S-00005	09

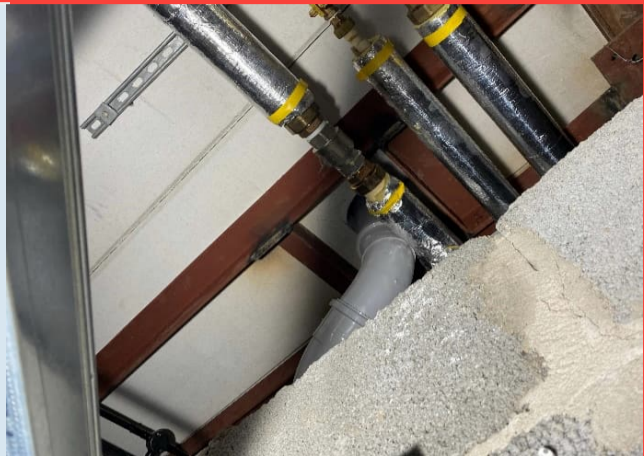
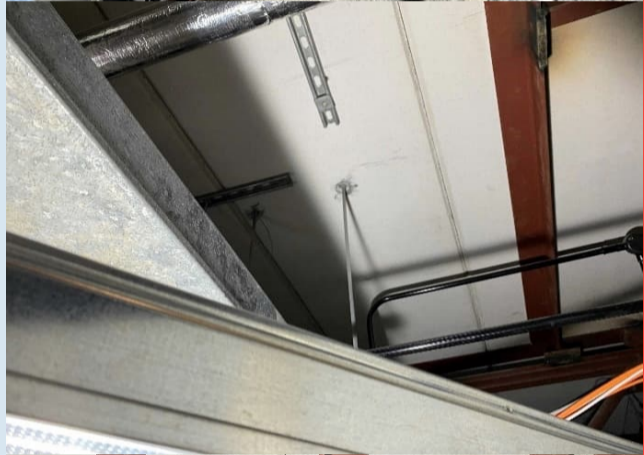
Location	General Condition Code	Repair Detail		Image
		Drawing No.	Detail No.	
L43	GRN.2.Mid.4.R.5.D150dia pipe, 200dia hole..7.8

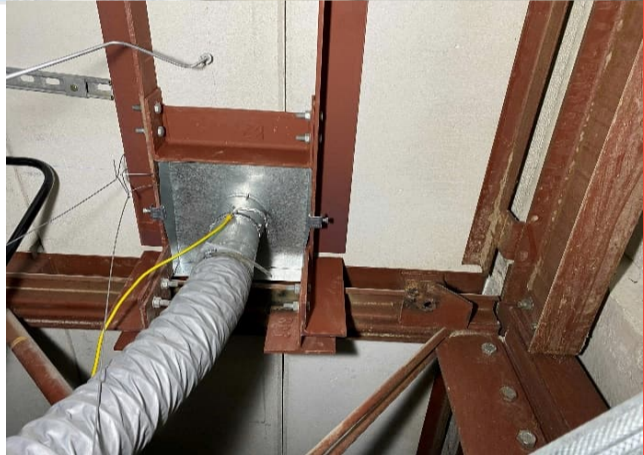
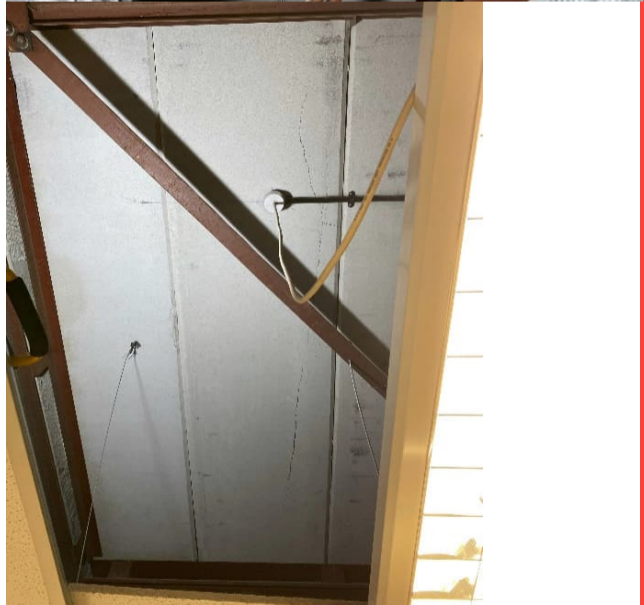
L44	RED.2.Edg.NR.5.D120dia pipe, cover plate.6.7.8.10	S-00005	08

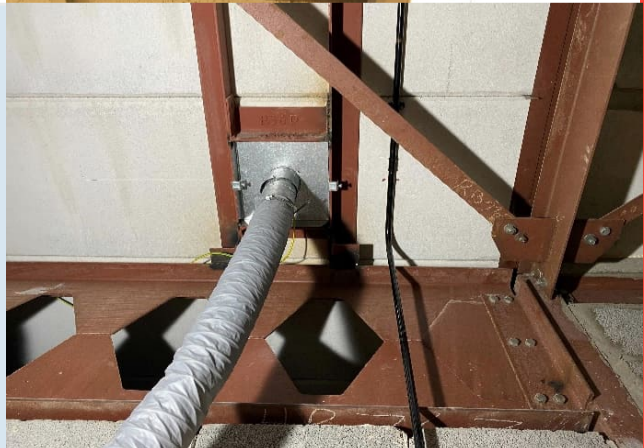
L45	GRN.Edg.4.NR.5.D120dia pipe. plate covering.7.8

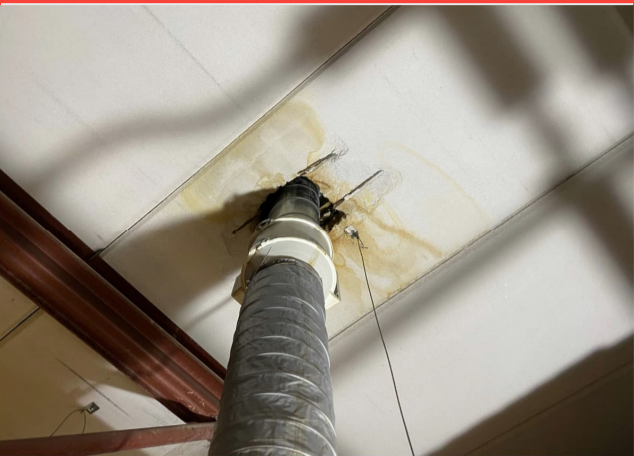
Location	General Condition Code	Repair Detail		Image
		Drawing No.	Detail No.	
L46	RED.Edg.4.NR.5.D150dia pipe, 250x250square hole.7.8	S-00005 S-00002	09 R1

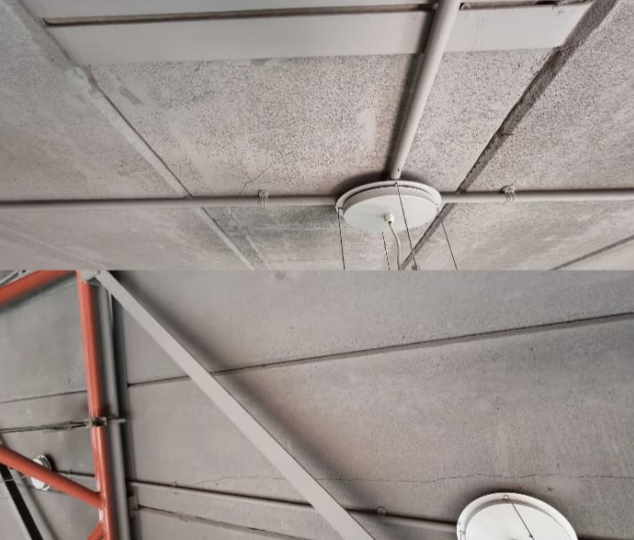
L47	GRN.Edg.4.NR.5.DC 460.7			
L48	GRN.Mid.4.R.5.DC 460 sq.7.8			
L49	AMB.1.2.Edg.NR.5.DC 150 diam.7.8.9	S-00005	09

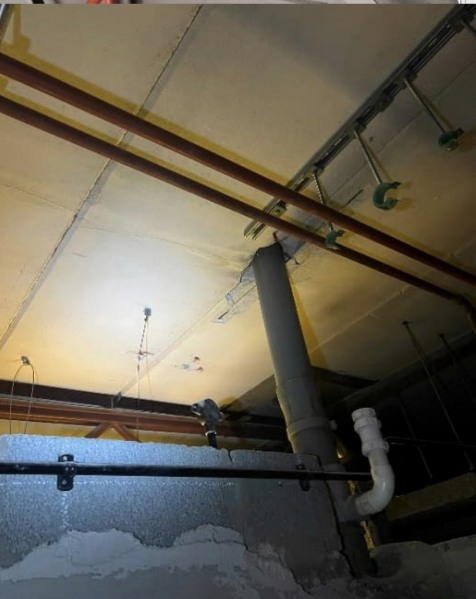
L50	RED.Mid.4.R.5.D150d pipe, 200 hole.8.10	S-00005 S-00002	09 R1

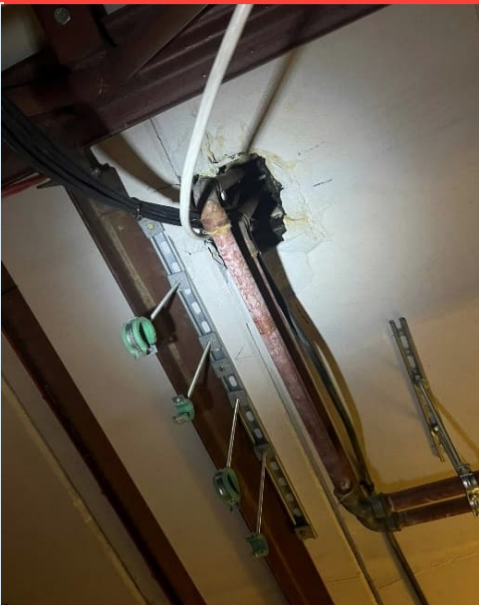
Location	General Condition Code	Repair Detail		Image
		Drawing No.	Detail No.	
L51	RED.2.Edg.4.R.5.D200x200 hole.8.10	S-00005 S-00002	09 R1

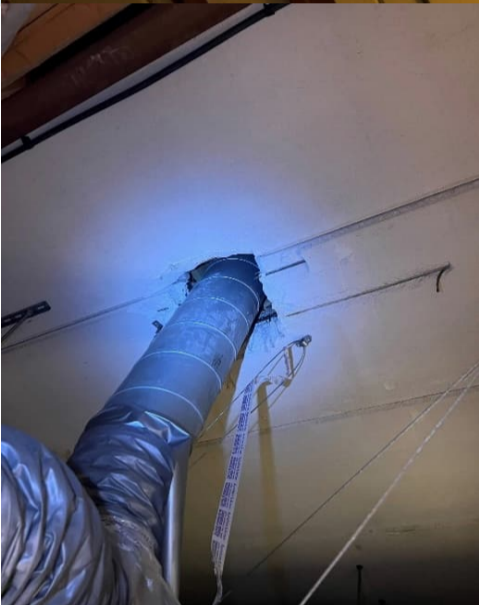
L52	RED.Mid.4.R.5.D300d pipe, 400 square hole.8.10	S-00005 S-00002	09 R1

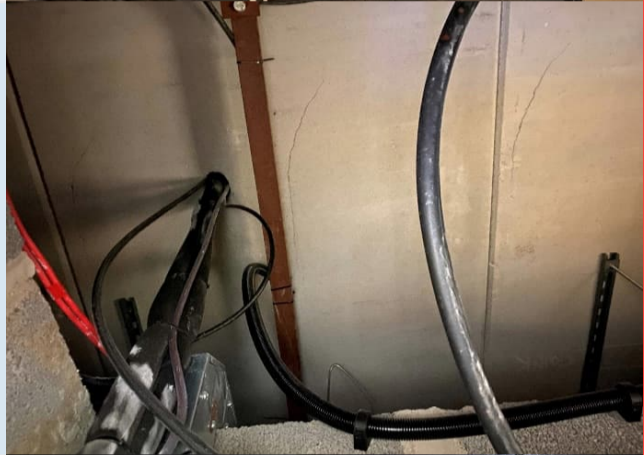
L55	RED.1.2.Edg.NR.5.D80dia, thick cables.8.10	S-00005	08

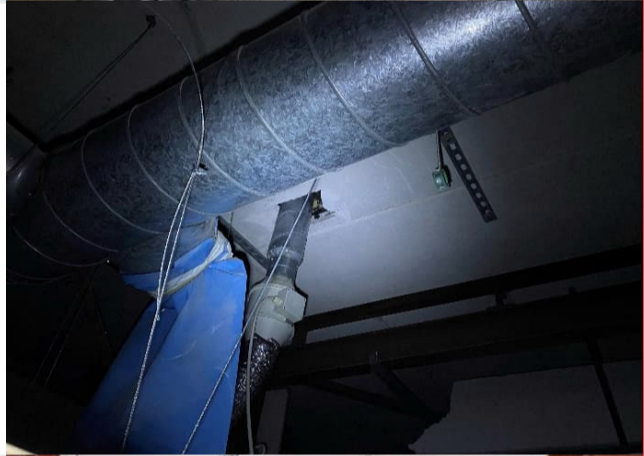
L56	RED.Edg.4.R.5.D200dia pipe, 300sq hole..8	S-00005 S-00002	09 R1

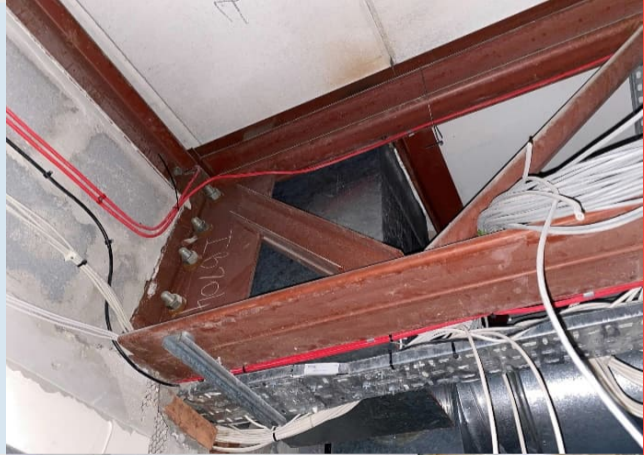
L57	GRN.Edg.NR.5.Dapprox 500sq pipe in 500hole.7.8

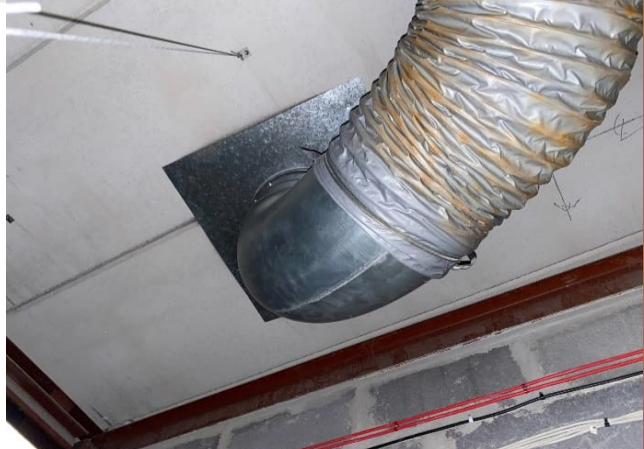
L58	RED.Edg.NR.5.D400dia pipe.8	S-00005	09

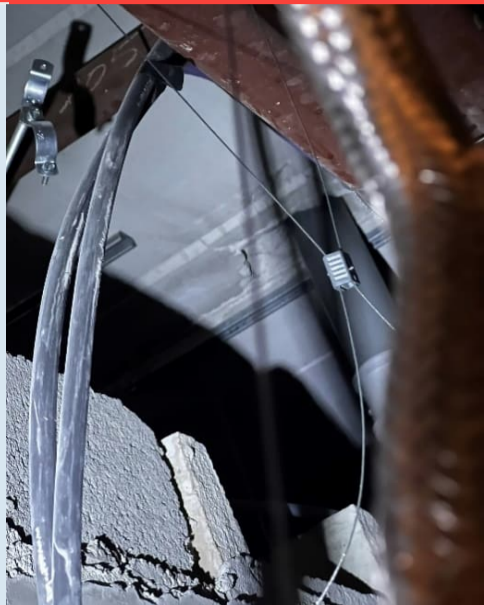
Location	General Condition Code	Repair Detail		Image
		Drawing No.	Detail No.	
L59	RED.Edg.4.NR.5.D200d pipe.8.9.10	S-00005 S-00002	09 R1

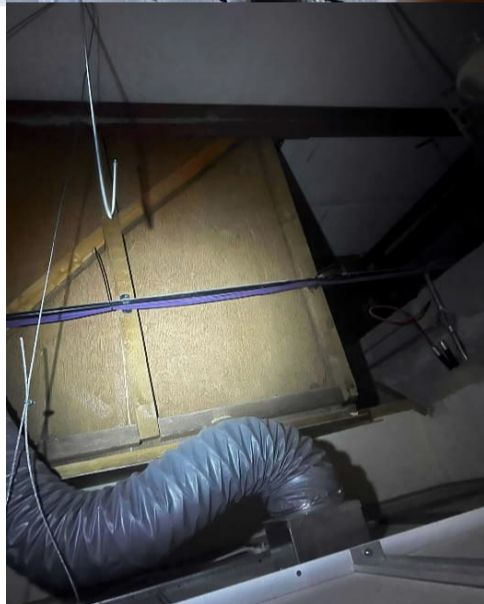
L60	GRN.Edg.NR.5.D1200x1200.7.8

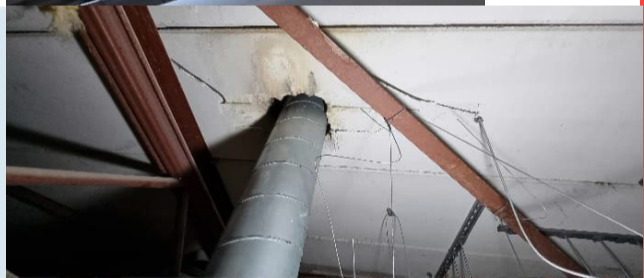
L61	RED.Edg.4.R.5.DC 250 sq.8.9	S-00005 S-00002	09 R1

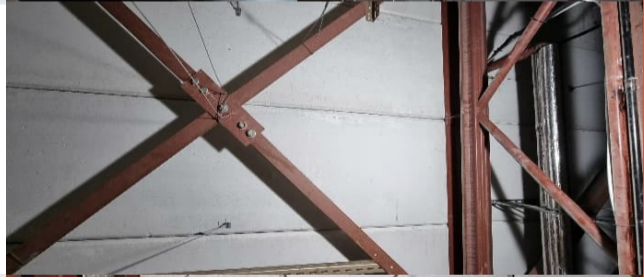
L62	AMB.2.Edg.NR.8	S-00005	08

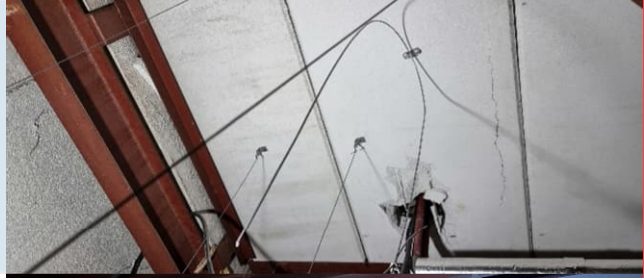
L63	RED.2.Edg.4.R.5.D150x150.8	S-00005 S-00002	09 R1

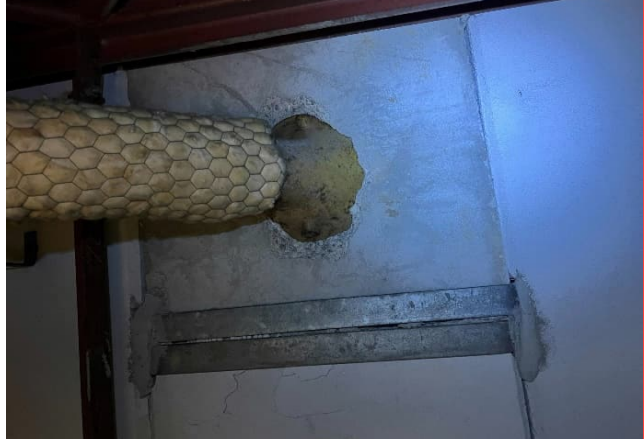
L64	RED.1.2.Edg.4.NR.5.7.9	S-00005	09

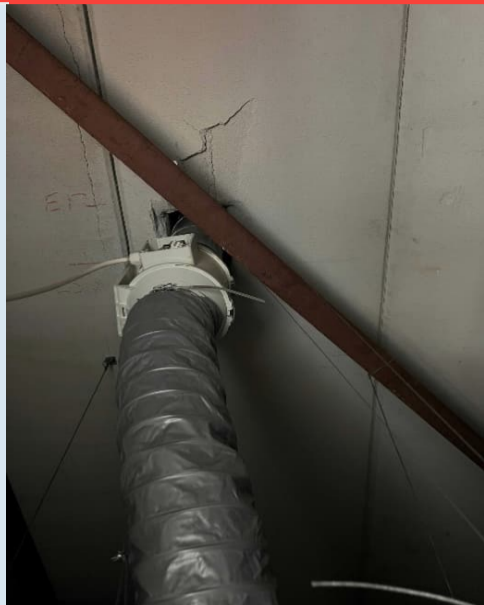
Location	General Condition Code	Repair Detail		Image
		Drawing No.	Detail No.	
L65	RED.2.Mid.4.R.5.DC 300 sq.9	S-00005 S-00002	09 R1

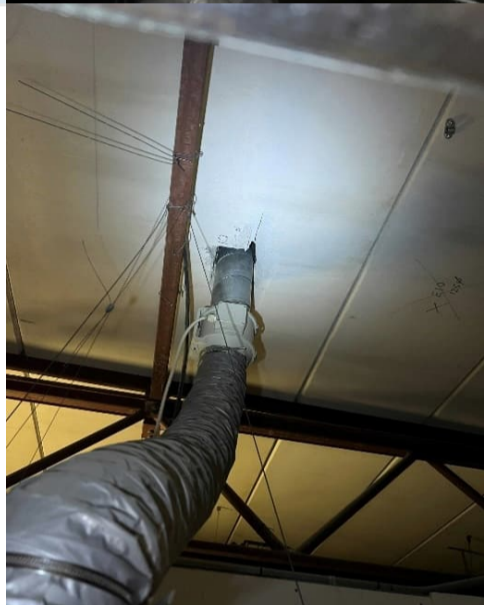
L66	RED.Mid.4.R.5.DC 300 sq	S-00005 S-00002	09 R1

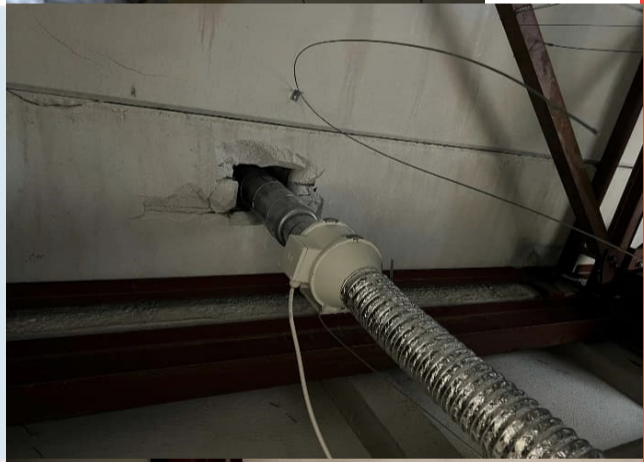
L67	RED.2.Edg.4.R.5.DC 250 sq.6	S-00005 S-00002	09 R1

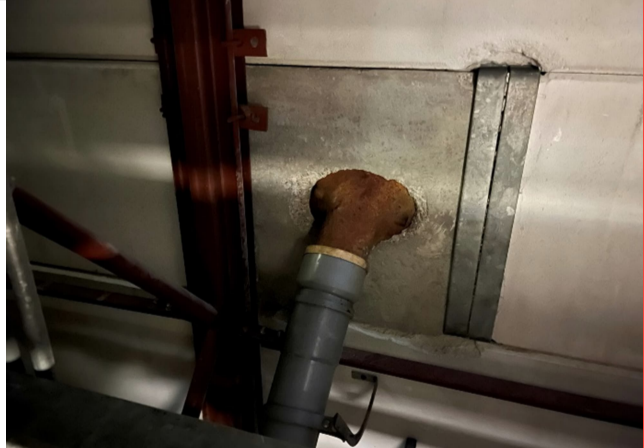
L68	RED.1.Mid.3.4.NR.5.7.8	S-00005	09

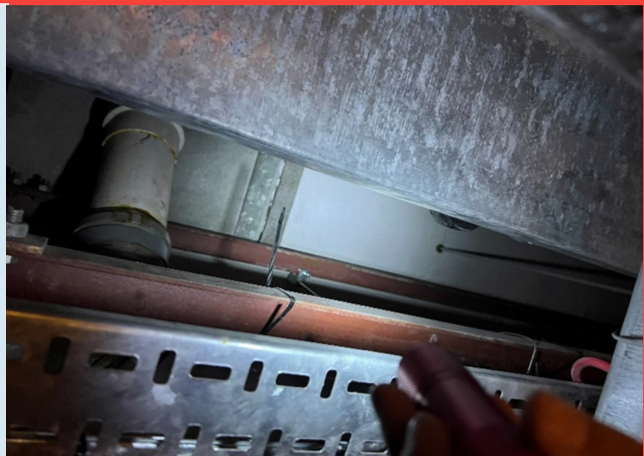
Location	General Condition Code	Repair Detail		Image
		Drawing No.	Detail No.	
L69	RED.1.Mid.4.NR.5.7.8	S-00005	09

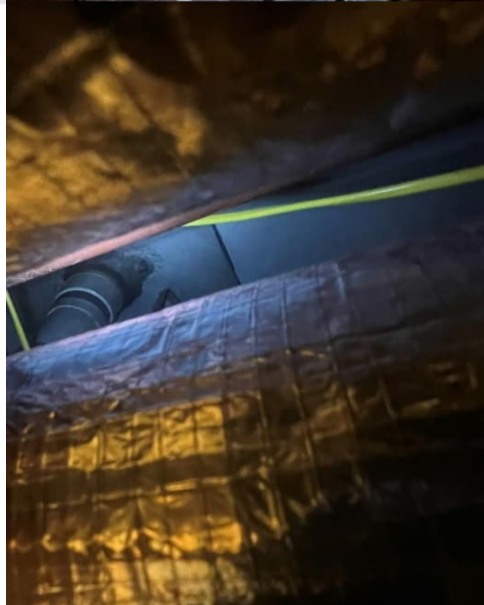
L70	AMB.Edg.4.NR.5.D200d pipe.7.8	S-00005	09
