## **Safety Action Notice**

Reference: SAN2406 Issued: 25 October 2024 Review Date: 24 October 2025

# Hoist spreader bar and looped sling attachments: sling loop may detach from spreader bar hook during lift

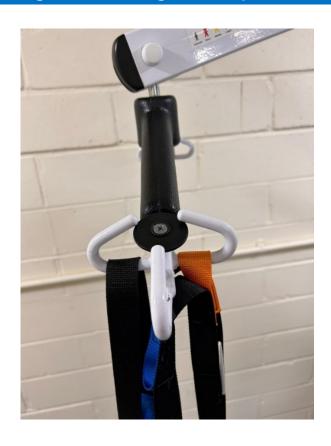
Figure 1

Correct position of the sling loop in the spreader bar attachment.

- pause the lift.
  - carry out a further visual and a physical check to ensure that that all the loops are securely seated within the spreader bar hook.

- If not, lower down the hoist and then adjust the sling loops accordingly.
- 9. If there is a problem with the spreader bar or sling loop attachments which means the lift cannot proceed safely and in accordance with the lifting plan:
